# Influence of Cutting Speed and Feed Rate on the Wear of an S-Type Mixed Ceramic Tool in Turning of AISI 4140 Hardened Steel

**Abstract:** In this study, the performance and the useful life of a mixed ceramic tool with S-type edge microgeometry are evaluated for the case of dry turning of AISI 4140 steel hardened to 55 HRC. The influence of the cutting speed and feed rate of the cutting parameters on the tool failure was investigated. The experiments were designed and analysed using the complete factorial design technique. Our results indicate that the cutting speed and feed rate values exert significant influence on the tool lifespan. Crater and flank wear occur in all cutting conditions. The predominant tool wear mechanisms are diffusion, abrasion, and adhesion, which are also known as attrition. The tool life curve and equation were established for the machining conditions of this investigation to achieve the subsequent optimisation of this process.

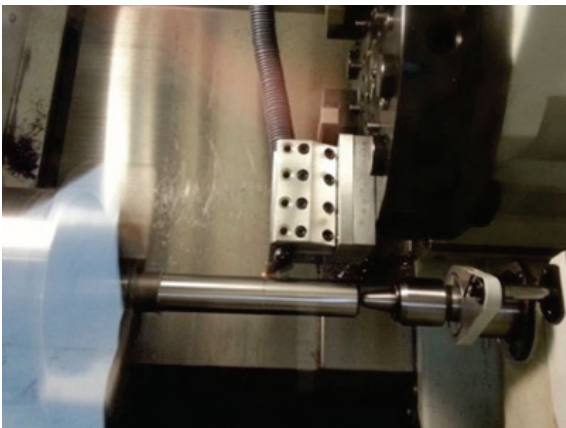
Fig. 1 shows the experimental setup for turning of AISI 4140 hardened steel.

Figure 1 View of the setup mounted for the tests

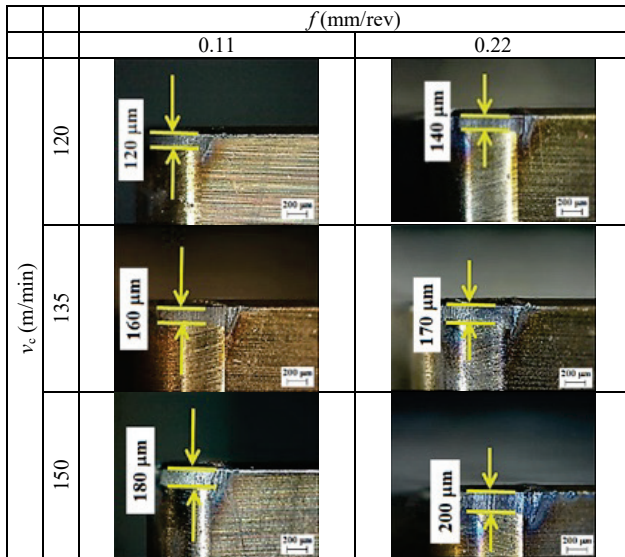
The flank wear ( $VB_C$ ) and notch wear ( $VB_N$ ) images, as a function of the variation of the cutting speed ( $v_c$ ) and the feed rate ( $f$ ) at a machining time of 50 min are displayed in Fig. 2.

Figure 2 Flank and notch wear after 50 min of machining

As expected, the highest  $VB_C$  values were noted at the fastest cutting speed (150 m/min) and the lowest values were verified at the lowest cutting speed (120 m/min). The increase of  $VB_C$  with the feed rate ( $f$ ) was also noted, although to a lower extent. This wear was directly influenced by the cutting speed due to the intense friction between tool and machined surface, whereas the predominant wear mechanism for the tool tip was mechanical abrasion due to the tool friction against a hardened piece. These results are similar to the findings obtained by other researchers [14-16, 18, 19].

Similarly, the effect of the increase in feed rate produced higher  $VB_C$  values. Notch wear probably occurs due to the increase of oxides that continuously form and

adhere to the tool in the regions near the chip-tool interface. The influence of the breakage of the adherence bonds between the oxides and the tool, which is promoted by the attrition mechanism, causes the removal of the surface material from the tool [26]. Another probable cause of notch wear is the tool fatigue that is caused by the variation in the free surface strength, accompanied by small lateral movements of the chip edges [27].

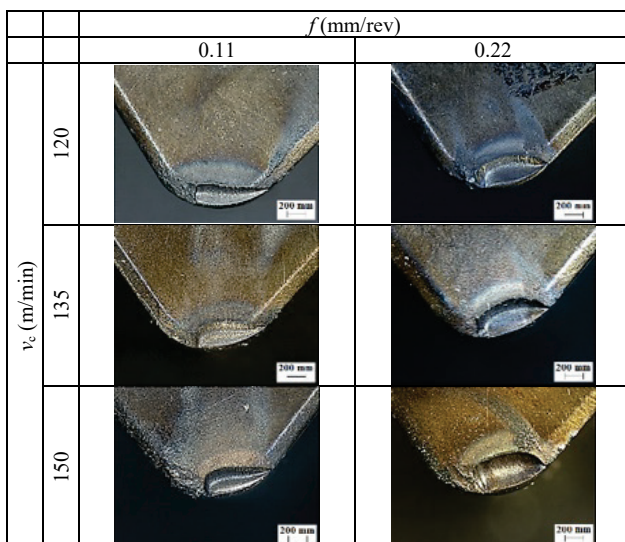
Figure 3 Crater wear after 50 min of machining

The images in Fig. 3 illustrate the crater wear under the influence of the cutting speed ( $v_c$ ) and feed rate ( $f$ ) variation for a cutting time of 50 min.

The friction between tool and chips produced the crater wear identified during the tests over the tool's rake surface. Due to the high cutting speeds, the diffusion wear mechanism is activated once the presence of 30% TiC in the tool matrix elevates the chemical affinity of the C present in the chemical compound TiC with the chemical elements in the workpiece material, which causes the removal of particles from the tool's rake surface. These results are consistent with the results obtained by investigations performed by [14-17, 27].

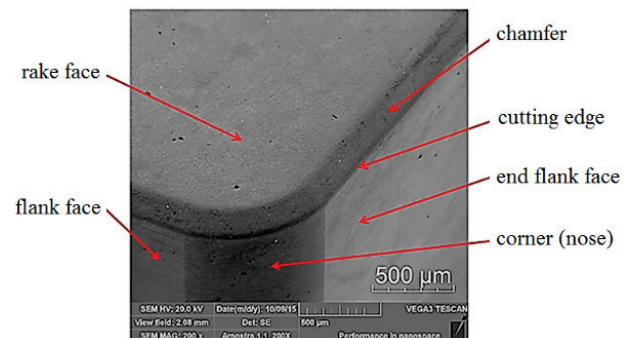
Fig. 4 illustrates the S-type ceramic insert prior to the tests (0 min of machining) and highlights the main points analysed by SEM. As shown in Fig. 5, the tool chemical composition spectroscopy (EDS) under these conditions demonstrated the presence of the following chemical elements: O, Al, Ti, C, N and Zr.

Figure 4 Detailed view of the plate before the tests (new)

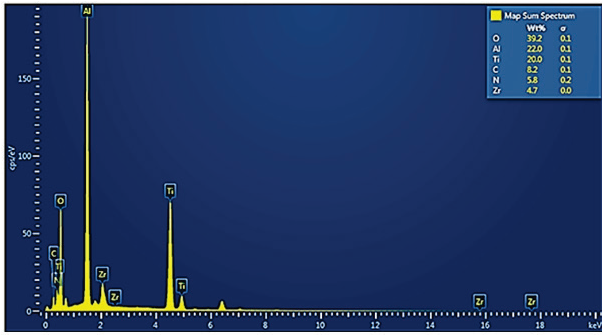
Figure 5 SEM/EDS chemical composition spectrum of the tool before the tests (new)

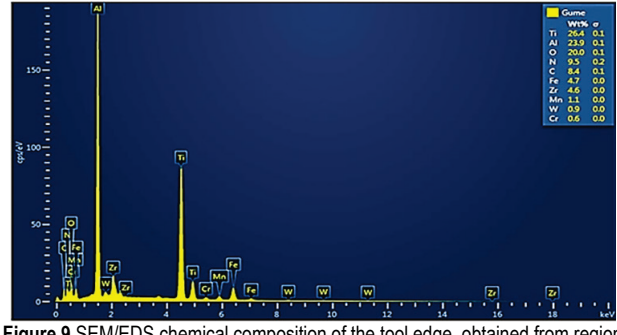
Figure 9 SEM/EDS chemical composition of the tool edge, obtained from region [B] of Fig. 8b

The results from the spectroscopies performed in the regions [A], [B] and [C] can be visualised in Fig. 8, Fig. 9 and Fig. 10, respectively.

The results obtained from EDS analysis indicated the presence of chemical elements from the machined material (Fe, Cr, Mn, W and Si) on the flank, on the edge and inside the crater, which is attributed to the joint actions of the diffusion, abrasion and attrition wear mechanisms.

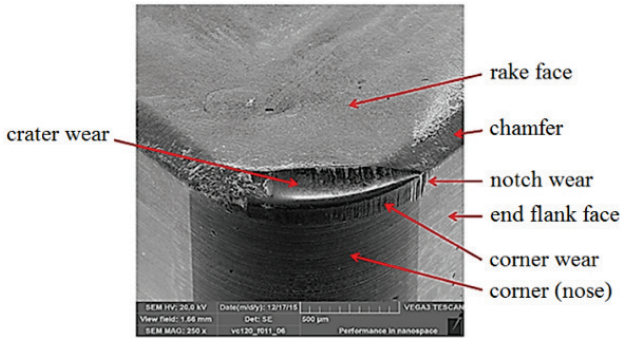
Figure 6 Detailed view of the ceramic tool pointing at the common failures that occurred at the end of the tests after 50 min of machining

The analyses performed through SEM indicated that the dominant failure modes were crater wear, corner wear and notch wear. No damage occurred in the tools during the tests. Regarding wear mechanisms, the attrition mechanism was present in all observations of the tool corner, edge and face.

Due to the friction between the workpiece and the tool tip produced by the hardened elements (carbides, nitrides and oxides) in the machined material and the removal of hard fragments from the tool, the presence of vertical marks parallel to the cut direction is the evidence of the tip wear by mechanical abrasion.

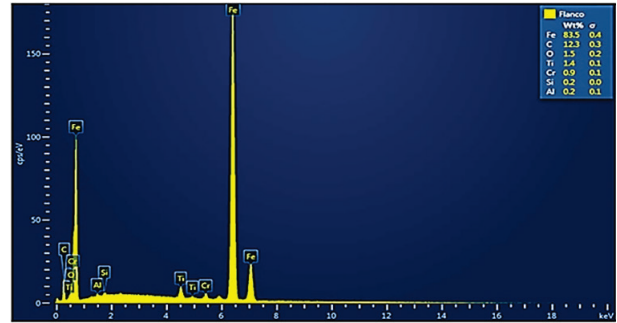
Figure 10 SEM/EDS chemical composition of the flank wear, obtained from region [C] of Fig. 8b

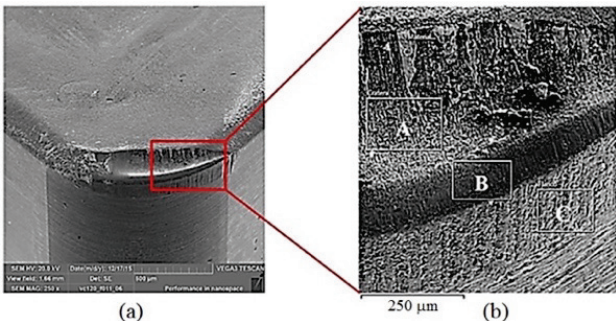
The tool tip observed with SEM/EDS under  $v_c = 120$  m/min and  $f = 0.11$  mm/rev is shown in Fig. 7a. Thus, the regions where the crater [A], edge [B] and corner wear [C] were analysed are represented in the image of Fig. 7b.

Figure 7 (a) Tool tip under the cutting conditions  $v_c = 120$  m/min and  $f = 0.11$  mm/rev; (b) tool wear regions: [A] face, [B] cutting edge and [C] flank

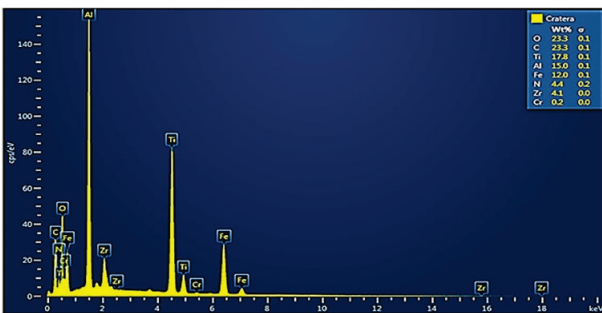
Figure 8 SEM/EDS chemical composition of the crater wear (face), obtained from region [A] of Fig. 8b

The crater identified in the tools primarily appears due to the diffusion wear mechanism once the presence of carbon (C) from the titanium carbide (TiC) of the ceramic plate matrix produces chemical affinity between the elements in the machined piece. Similar results have been cited in other studies [12, 14, 19, 27-32].

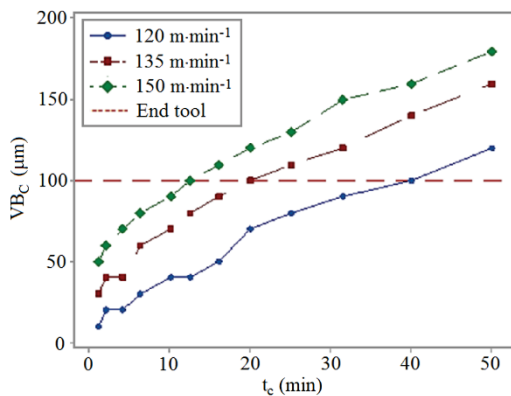
The tool life curve is dependent on a series of factors during the machining process. It is highly dependent on the cutting speed and is dependent to a lesser extent on the feed rate. Fig. 11 and Fig. 12 illustrate the tip wear for different cutting speeds, considering the feed rates of  $f = 0.11$  mm/rev and  $f = 0.22$  mm/rev.

Figure 11 Flank wear ( $VB_c$ ) as a function of cutting time for the condition  $f = 0.11$  mm/rev

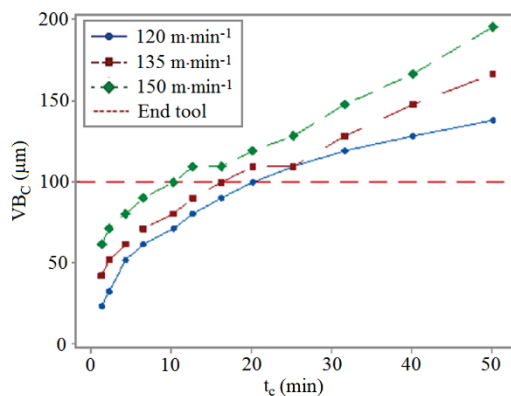
Figure 12 Flank wear ( $VB_c$ ) as a function of cutting time for the condition  $f = 0.22$  mm/rev

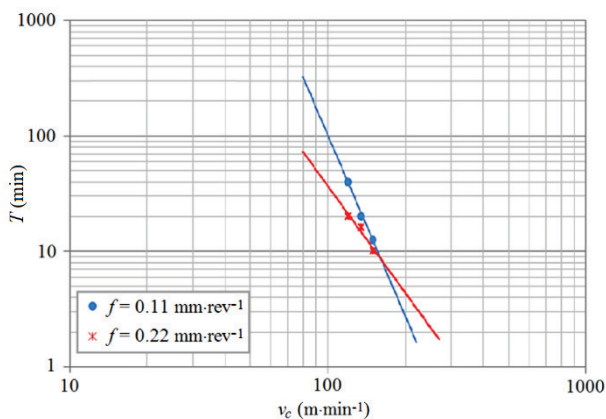
Eq. (1) and Eq. (2), with  $R^2 = 0.994$  and  $R^2 = 0.946$ , respectively, rule the tool life curves denoted by Fig. 13

using log-log scale plot for the corresponding values of feed rate (0.11 and 0.22 mm/rev respectively).

Figure 13 Tool life curve

As shown in Fig. 13, for the lowest feed rate condition ( $f = 0.11$  mm/rev), the tool life ( $T$ ) is more sensitive to the

increase in cutting speed ( $v_c$ ), and the curves intersect at  $T = 8.5$  min and at a cutting speed of  $v_c = 160$  m/min.

$$T = (2.8607 \times 10^{12}) \cdot v_c^{-5.226} \quad (1)$$

$$T = (5.3671 \times 10^7) \cdot v_c^{-3.083} \quad (2)$$

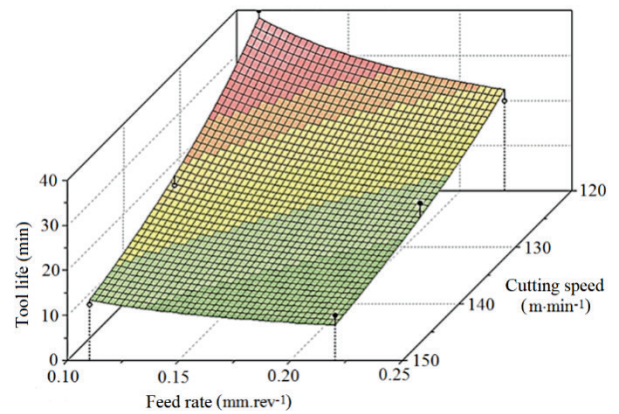
Figure 14 Surface of the combined effects of the cutting speed ( $v_c$ ) and the feed rate ( $f$ ) over the lifespan ( $T$ )

Eq. (3) represents the surface plot graph 3D assisted by LAB Fit presented by Fig. 14 ( $R^2 = 0.953$ ).

A significant superiority of the cutting speed ( $v_c$ ) is observed over the tool life ( $T$ ) (exponents of Eq. 3). The effect of  $v_c$  on  $T$  is larger at smaller feed rates ( $f$ ), and the effect of  $f$  on  $T$  is more pronounced at lower values of  $v_c$ .

$$T = (4.1435 \times 10^{10}) \cdot f^{-0.773} \cdot v_c^{-4.70} \quad (3)$$
