## Soil Corrosion of the AISI1020 Steel Buried Near Electrical Power Transmission Line Towers

Soil corrosion of carbon steel samples buried up to hundred days close to a high voltage power transmission line tower was examined by weight loss vs. time. A higher weight loss was observed if the samples were electrically connected to the tower than if they were not. This was attributed to the influence of alternating current (AC) signals induced in the soil by the transmission line. This field study showed for the first time the influence of the AC power line on the buried structure of the tower, while other studies so far were focused only on AC corrosion of cathodically protected coated pipelines, running parallel to the transmission line. An improved method was used to measure weight loss by descaling in Clark solution. The new method substitutes discontinuous measurements, proposed in the ASTM-G1-90 standard, by *in situ* measurements of the weight loss during descaling, using a computer controlled microbalance.

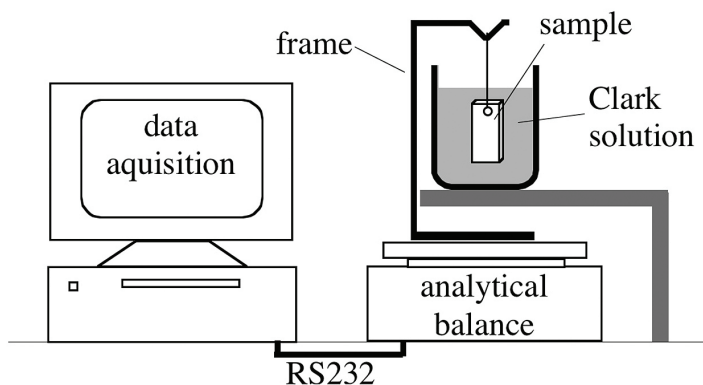
**Figure 1.** Experimental scheme for *in situ* weight loss measurements during oxide dissolution of corroded samples in Clark solution.

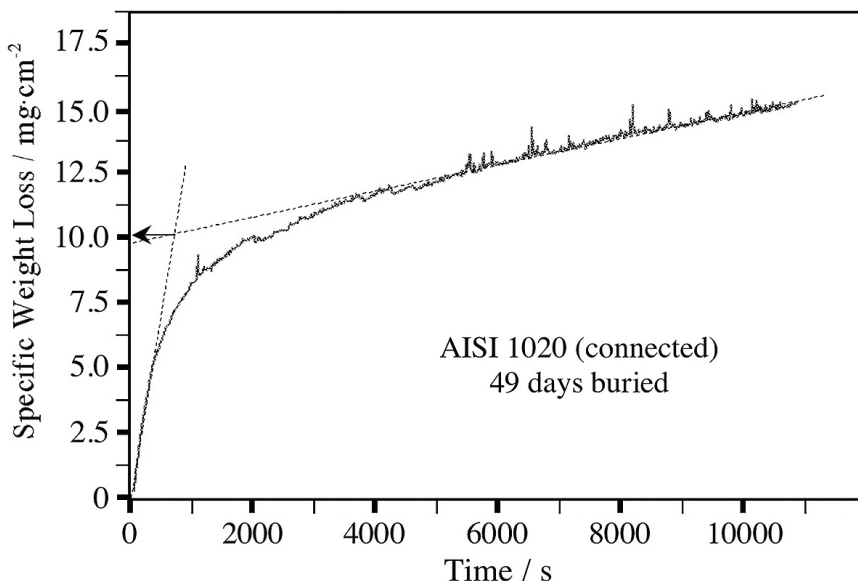
Figure 2 shows a weight loss *versus* time curve obtained during immersion of corroded samples in Clark solution. Purpose of this solution, defined by ASTM G1-90 standard<sup>20</sup>, is the dissolution of solid corrosion products formed during exposure to the soil. Clark solution according to ASTM G1-90 consists of HCl, Sb<sub>2</sub>O<sub>3</sub> and SnCl<sub>2</sub>. Singh et al.<sup>21</sup> describe the function of its ingredients as follows: Sb<sub>2</sub>O<sub>3</sub> acts as inhibitor for acid corrosion of steel and has an efficiency of 98%. Oxides are dissolved by HCl, according to:

The initially faster weight loss in Figure 2 can be attributed to the chemical dissolution of corrosion products. When uncovered, bare metal surface is exposed, the dissolution rate slows down due to inhibition of the acid corrosion and also oscillates. Evolution and detachment of adhered H<sub>2</sub> bubbles were observed at this phase and explains the weight oscillation during an electrochemical process of metal dissolution. A self-developed computer program fitted in real-time the acquired weight data during dissolution

in the Clark solution with two straight lines, one for the processes of chemical dissolution of corrosion products and another of the acid corrosion of the steel substrate, respectively. The oxide-weight loss was determined from the intersection of these two lines, as shown in Figure 2 and corrected for the buoyancy due to solution displacement by Equation (3a) and converted into metal loss by Equation (3b) as explained below.

Figure 2. *In situ* measurement of specific weight loss during exposure of corroded sample to Clark solution.

where  $M_{Fe}$  and  $M_{FeOOH}$  are the molar masses of Fe and FeOOH. If only Fe is being dissolved by the Clark solution, as expected for the second part of the dissolution curve of Figure 2, then  $k$  in Equation (3a) will assume a value of 0.83.

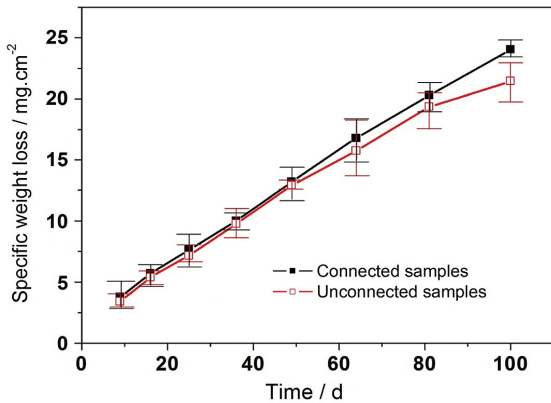
Figure 3 shows the weight loss of samples exposed during a period up to 100 days in the soil. Each point of the diagram represents the average of three measurements. The weight gain of samples connected to the transmission tower is higher than the one shown by unconnected ones. Weight loss by oxide formation of both, connected and unconnected samples follows a time law of exponent lower than one. This becomes more evident in the comparison of corrosion rates in Figure 4, calculated from the slopes  $(\Delta M/A)/Dt$  at each time interval in Figure 3. The diagram shows that the differences between connected and unconnected samples are higher for short exposure times. Nevertheless, the corrosion rate of the samples connected to the tower remains higher during the whole period of test, revealing a possible influence of AC signals induced by the transmission tower. The corrosion attack at the buried samples is not uniform. When only the attacked area determined by optical inspection is considered for the weight loss per area, the

Figure 3. Specific weight loss per geometric area versus exposure time.

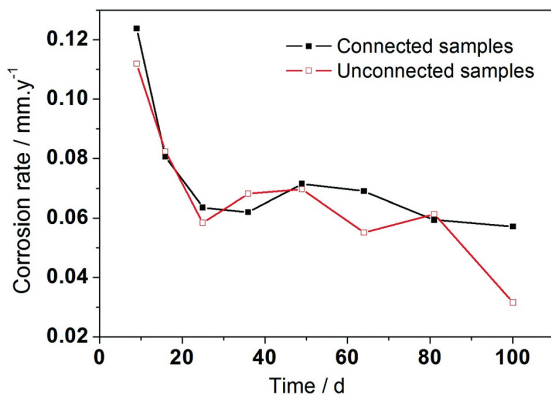
Figure 4. Corrosion rate during exposure time of buried samples related to the geometric surface area.

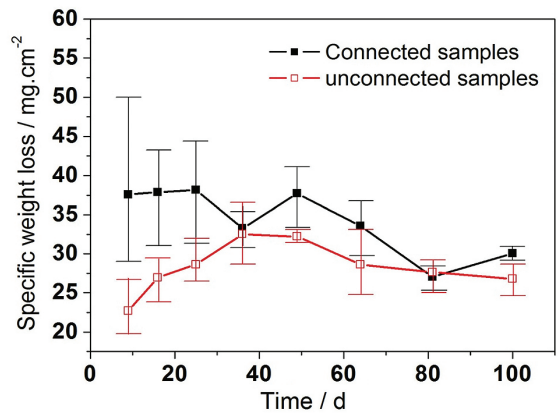
differences between connected and unconnected samples become higher for short exposure periods, as seen in Figure 5. This means that initially a smaller area is attacked at the connected samples. During the entire exposure period of 100 days the corrosion attack spreads laterally over nearly the whole surface (Figure 6, right side). The mean corrosion rate related to the attacked area decreases with the exposure time (Figure 6, left side), thus diminishing the differences between weight losses per geometric (Figure 3) and per attacked area (Figure 5). This behavior is in agreement with the results of other authors, which reported a tendency to more localized corrosion attack in cases of AC corrosion<sup>24</sup>.

Figure 5. Specific weight loss per attacked area versus exposure time.

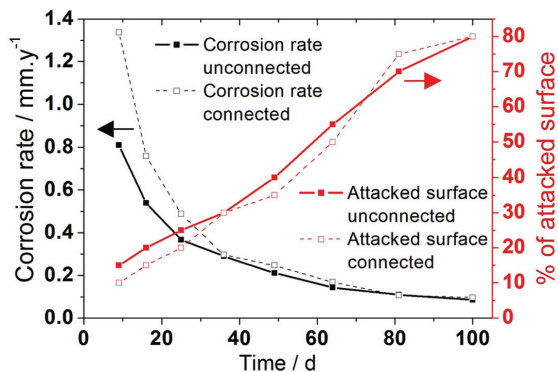
Figure 6. Mean corrosion rate during exposure time per attacked surface and percentage of attacked surface versus total exposure time.

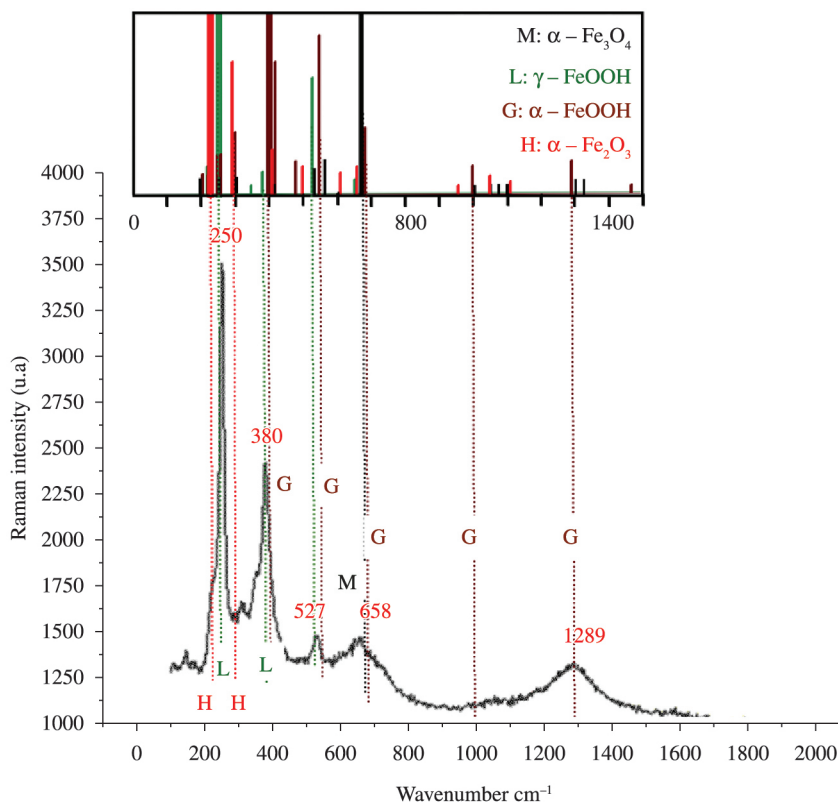
**Figure 7.** Raman spectrum of the corrosion products for AISI 1020 exposed during 64 days connected to the power line tower. Insert: Schematic normalized Raman spectra of lepidocrocite (L), goethite (G), magnetite (M) and hematite (H).

Figure 7 shows the Raman shift spectra acquired on the AISI 1020 after an exposure time of 64 days connected to the power line tower. Normalized schematic Raman spectra of possible corrosion products were extracted from the literature<sup>28</sup> and plotted schematically on the insert of Figure 7. Similarly to what is observed for other cases of corrosion of carbon steel, such as corrosion in humid atmospheres<sup>24</sup>, in aerated solutions<sup>29</sup>, as well as soil corrosion of unpolarized buried steel<sup>30</sup>, the main corrosion product observed in the present work was lepidocrocite

( $\gamma$ -FeOOH) followed by goethite ( $\alpha$ -FeOOH) and in a lower intensity also magnetite ( $\alpha$ - $Fe_3O_4$ ). No significant differences could be observed between Raman spectra of connected and unconnected samples under the influence of induced AC signal.
