### MIGRATION OF A LEVONORGESTREL- RELEASING INTRAUTERINE DEVICE (LNG-IUD): CAN WE TRUST ON ULTRASOUND IMAGE?

*Migração de um dispositivo intrauterino com levonorgestrel: é possível acreditar na ecografia?*

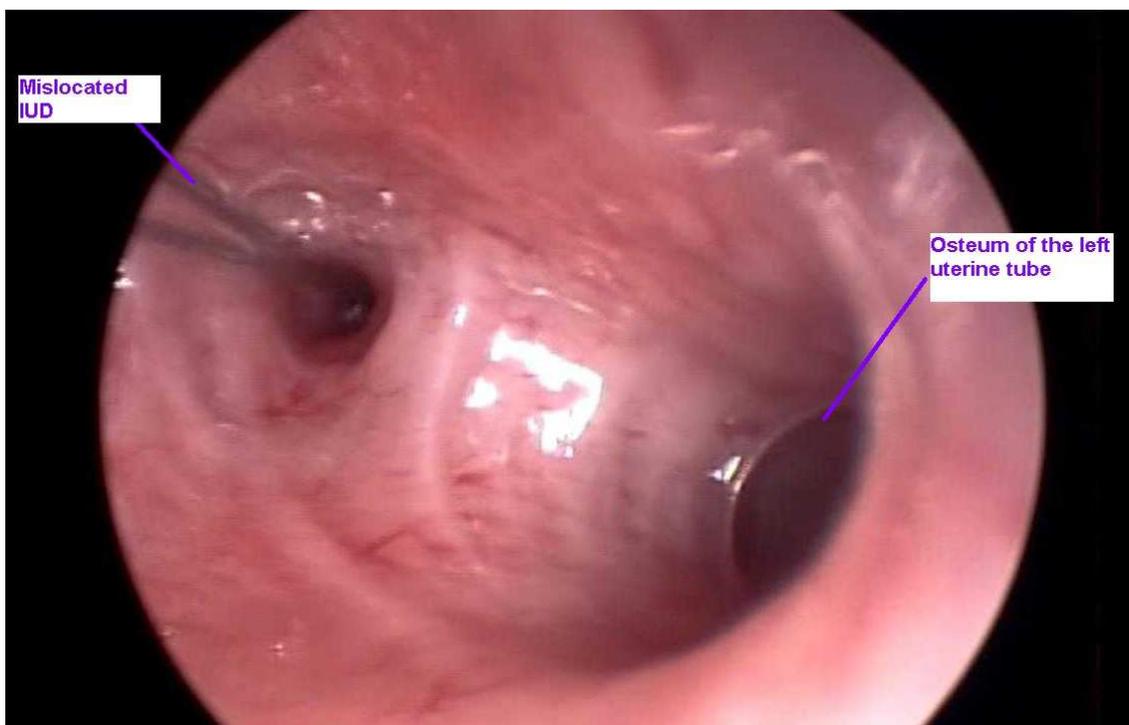
We report the case of a nulliparous 33-year-old woman who had a uneventful insertion of levonorgestrel-releasing intrauterine device (LNG-IUD; Mirena, Schering, Brazil) inserted on august/2005. She was amenorrhic from august 2005 to may 2006, when she referred the beginning of an intermittent spotting. On september/2006, she had a normal transvaginal ultrasound, showing a well-placed device. One year later, she informed the occurrence of regular menstrual cycles, but with menorrhagia. At that time, during the physical examination, the retrieval thread was not visible at the cervix. Another ultrasound was then performed, showing a device outside the uterine cavity, probably in the uterine serosa (Figure).

Laparoscopy and hysteroscopy were scheduled. The hysteroscopy identified apparently two osteum related to the left uterine tube, one being the pathway created by the migrating device. It had not perforated the serosa of the uterus yet, being easily removed through hysteroscopy. Laparoscopy was cancelled.
